REFURBISHMENT STRUCTURAL STRENGTHENING WITH SIKA SYSTEMS

FOR OWNERS OF BUILDINGS AND CIVIL ENGINEERING STRUCTURES

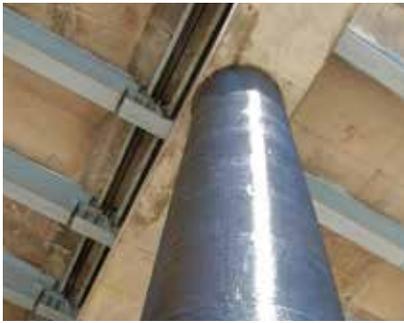
COLUMN STRENGTHENING

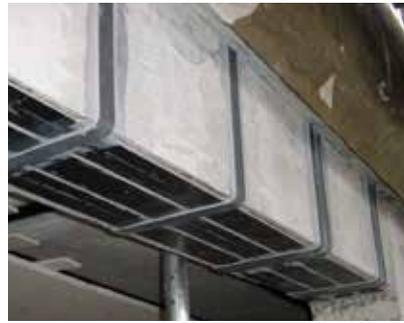
BEAM STRENGTHENING

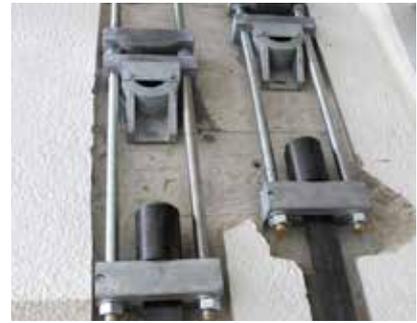
PRE-STRESSED STRENGTHENING

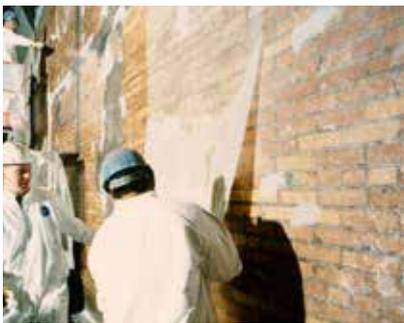
SEISMIC UPGRADING /EARTHQUAKE DAMAGE REPAIR

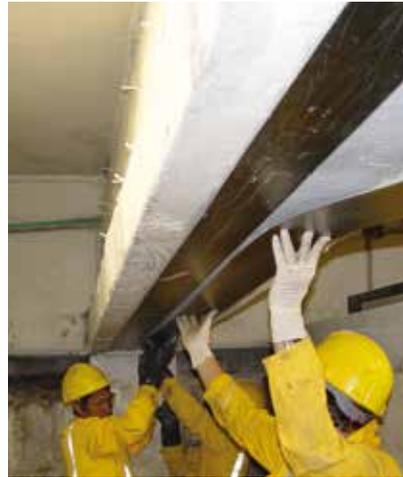
The Sika CarboDur® System is the most widely recognized and established carbon-fiber-reinforced polymer (CFRP) strengthening solution available worldwide. It consists of Sika CarboDur® CFRP plates and rods, together with the structural epoxy resin based adhesives Sikadur®-30 and Sikadur®-30 LP. This simple, tested and well proven, highly durable system has outstanding performance. With the Sika CarboHeater curing times can be accelerated and down time minimized, even at lower temperatures.

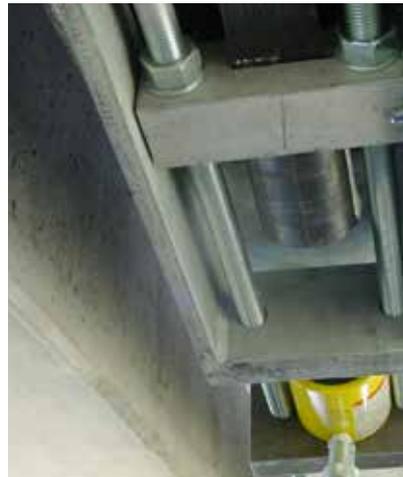
Post-tensioning: a force is applied to create permanent stress in a structure, so that it can withstand load more efficiently or with less total deflection. In conventional post-tensioning, the load is put on steel tendons within the concrete structure, however with the Sika CarboStress® system, the advantages of the Sika CarboDur® CFRP plates and post-tensioning techniques are combined to form a unique active external strengthening solution.

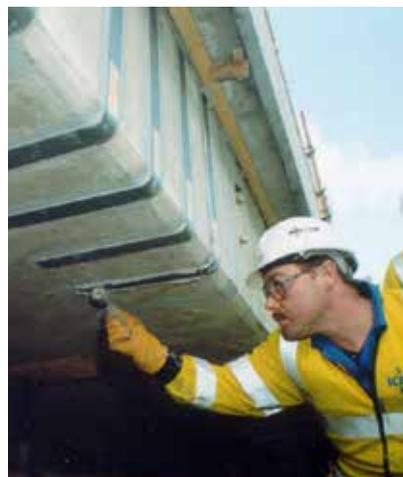
The shear capacity of concrete beams can be increased by the external applied Sika CarboShear L-shaped profiles. Installation is fast and easy, excellent anchorage is assured and no drilling through the top slab is required.

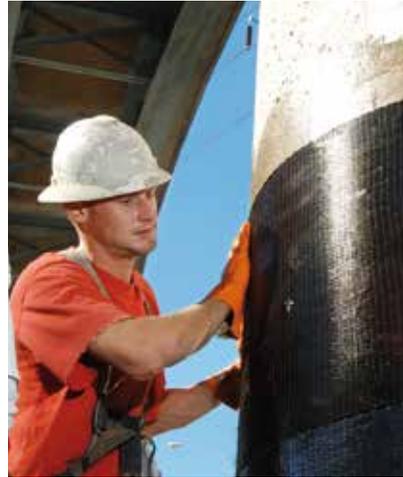
The SikaWrap® fabric strengthening system consists of woven or stitched, unidirectional, carbon and glass fibre fabrics and Sikadur® impregnating resins. This system provides a wide range of solutions to meet different demands on many different types of projects. The installation is extremely flexible and accommodating of different surface planes and geometry, making this a very multi-functional material for many applications including confinement, shear, seismic upgrading and weak substrate strengthening.

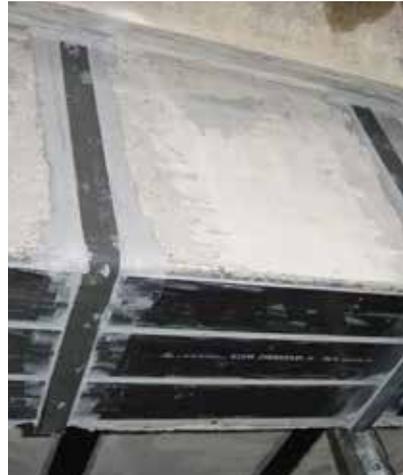
The combination of all of the different Sika Strengthening Systems is possible and allows unique solutions to be engineered, especially for:

- Shear and flexural strengthening
- Enhanced end anchorages

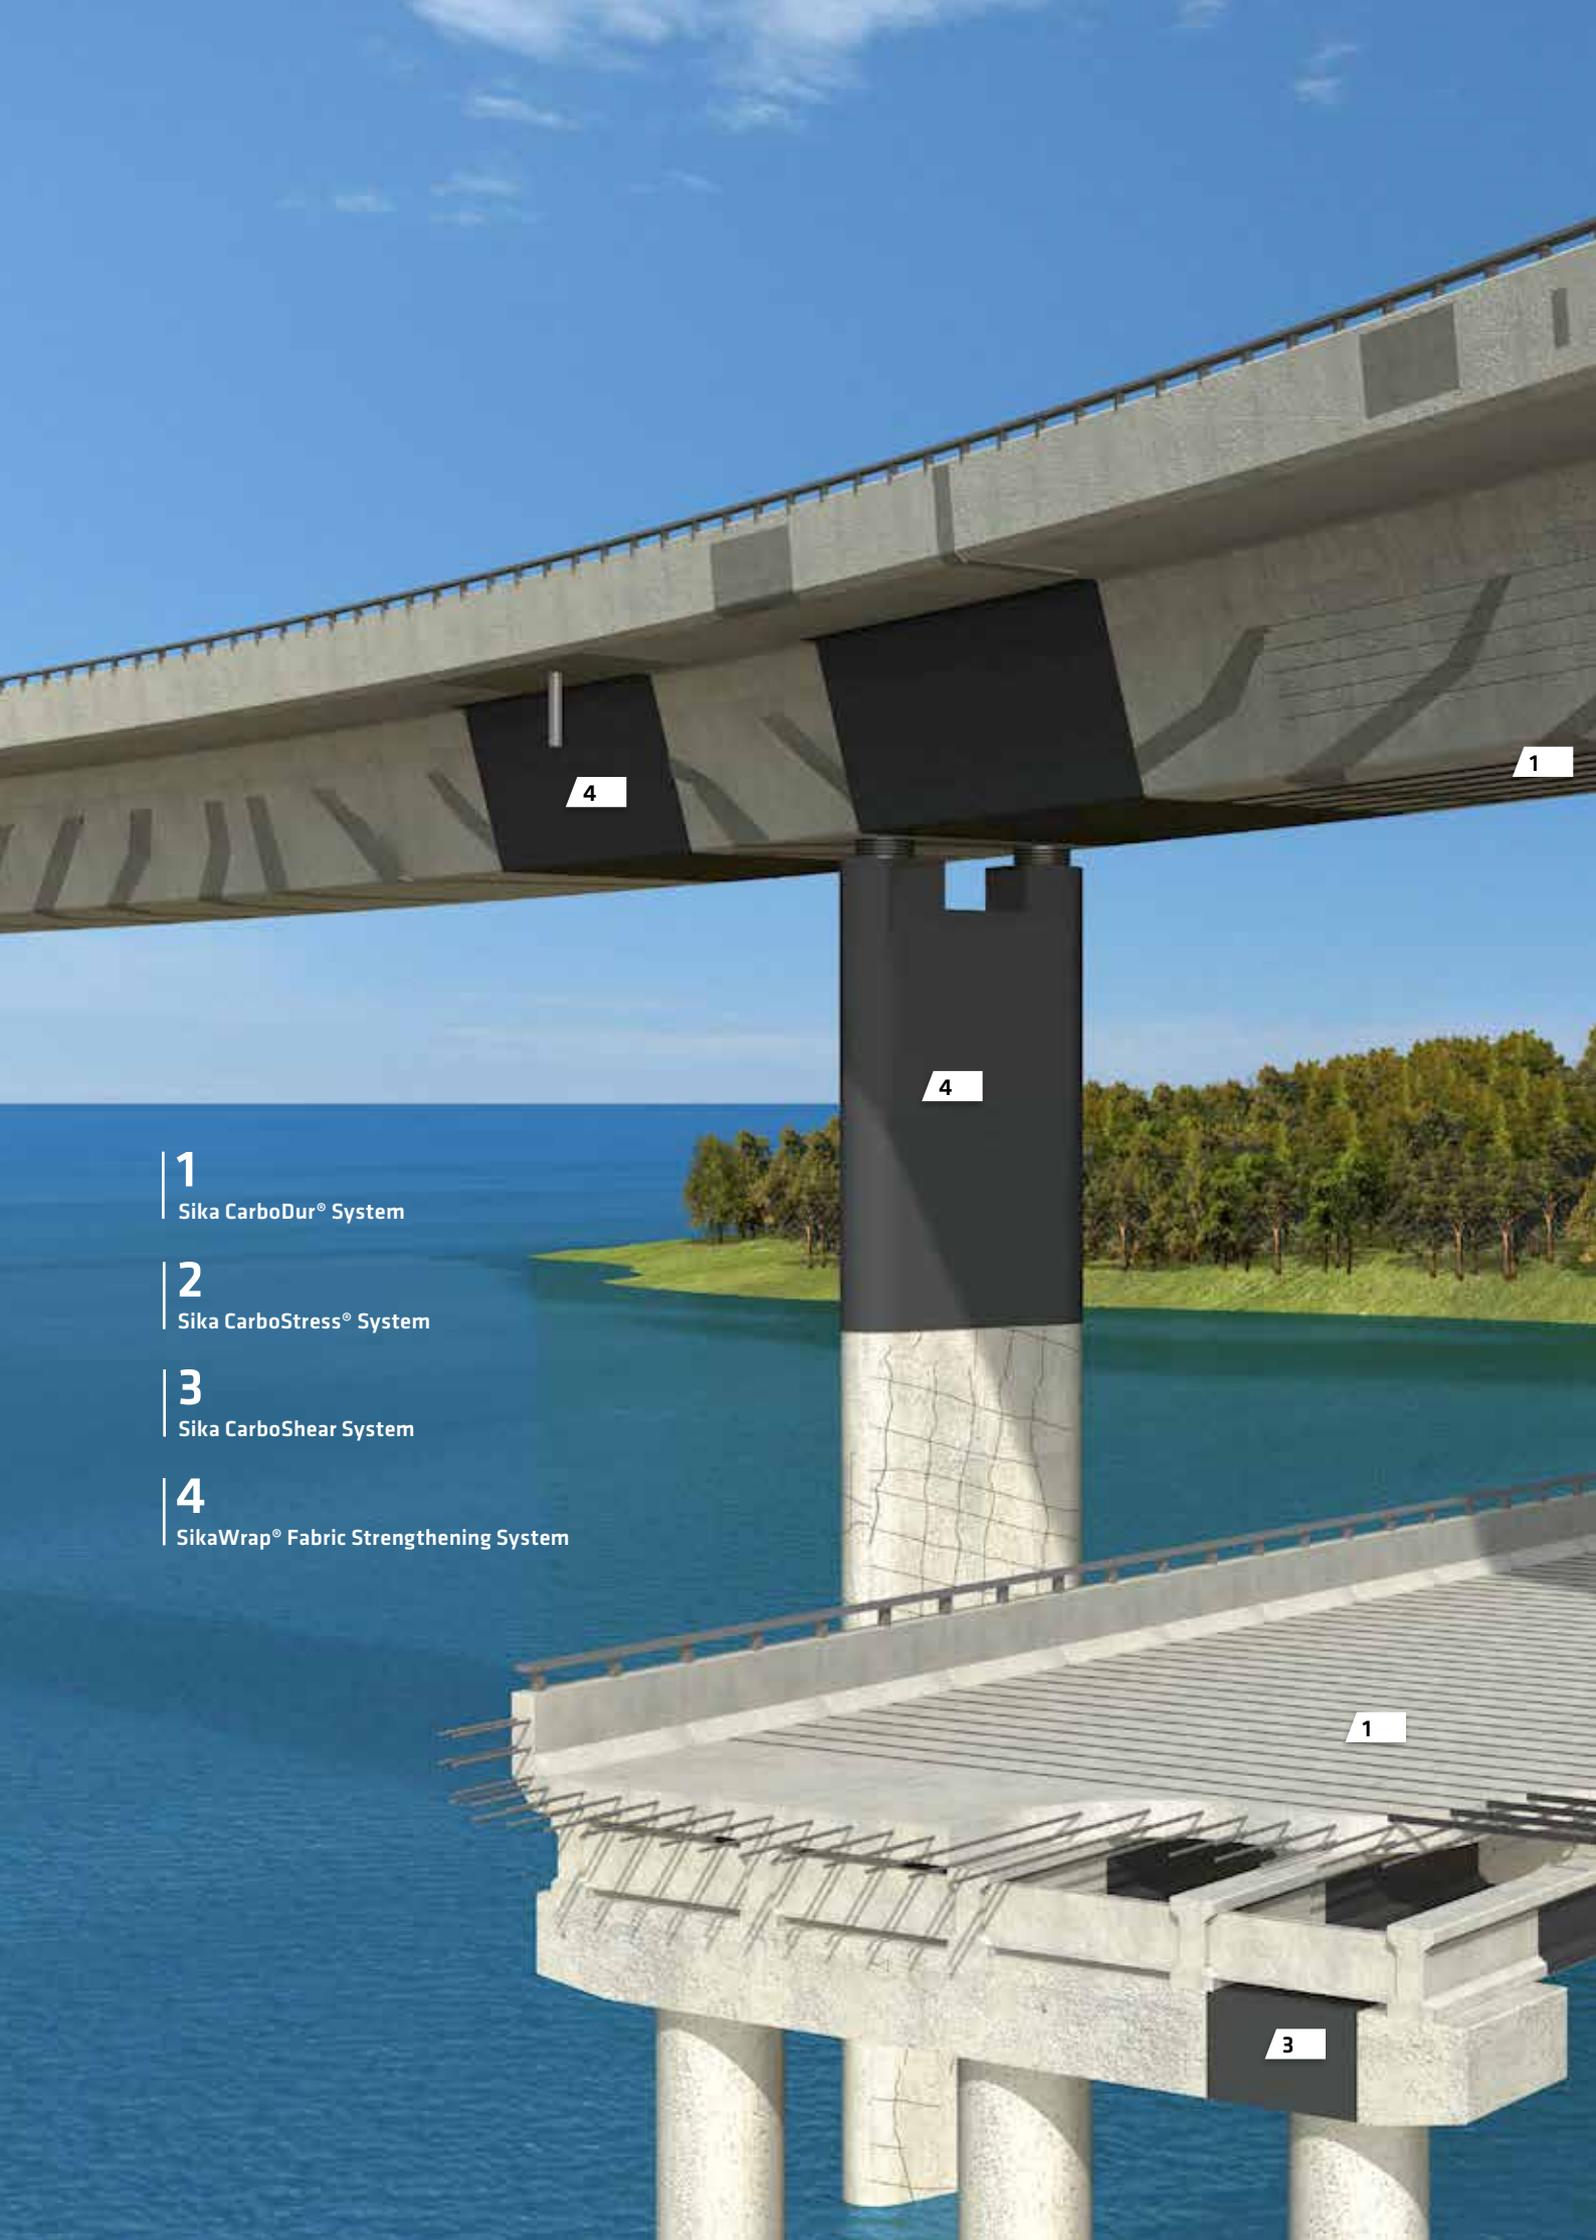
Sika CarboDur® System

Sika CarboStress® System

Sika CarboShear System

SikaWrap® Fabric Strengthening System

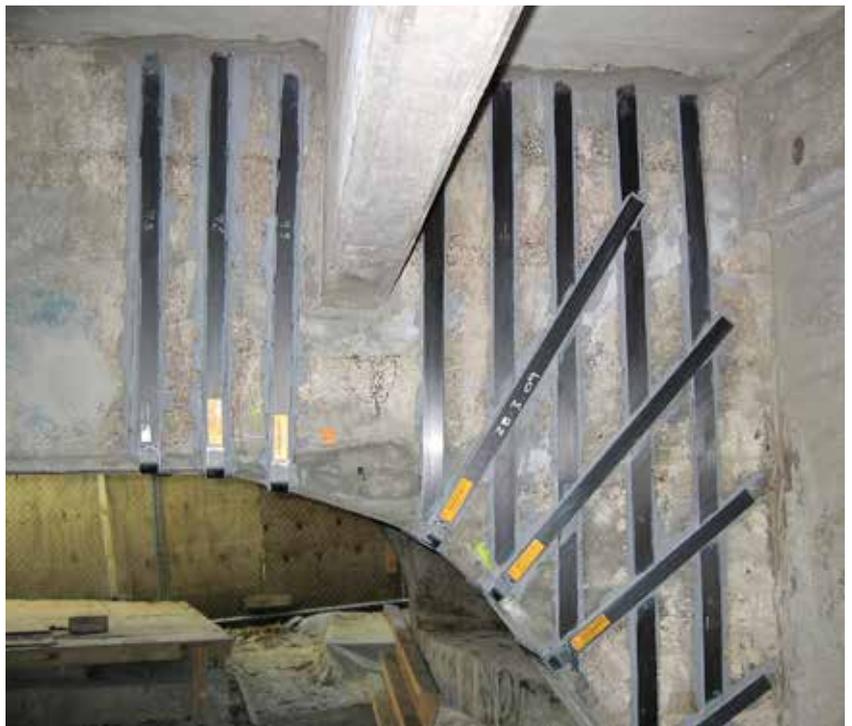
Sika CarboDur® strips and CarboShear L plates bonded to the concrete structure.

Sika CarboDur® CFRP plates were installed on the underside of the reinforced concrete beams to provide additional mid-span movement resistance. The Sika CarboShear L shaped CFRP profiles were then installed, in pairs, around the beams and up into the deck slab to improve the shear performance.

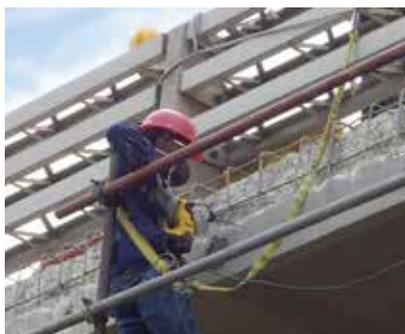
Substrate preparation

Few years after the initial concrete repair works were completed shear cracks were noticed in the beams and the requirement for structural strengthening was decided by the Engineers. After sealing and filling the cracks with Sikadur® injection resin, the substrate was prepared and a lightweight SikaWrap® fabric strengthening system was applied in two directions and finally the areas were covered with a SikaTop® coating.

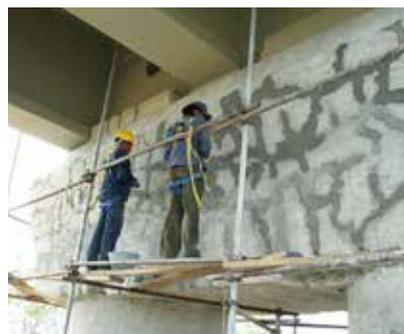
Repair

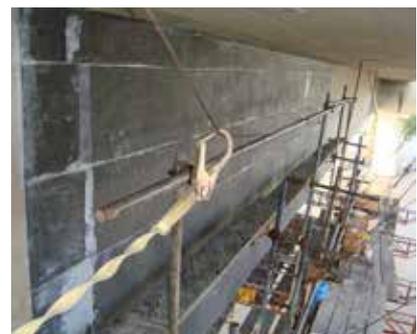
Strengthening with SikaWrap®

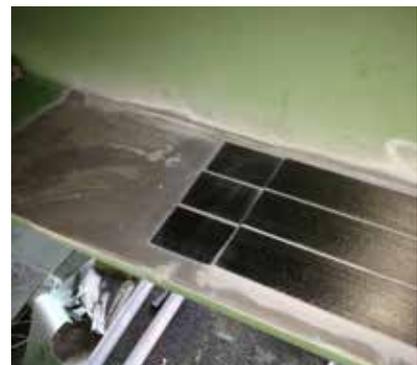
Two layers of Sika CarboDur®

CarboDur® system. After the steel substrate was cleaned and prepared by abrasive blast cleaning, the prefabricated CarboDur® CFRP plates were then immediately bonded to the steel surface with Sikadur® structural adhesive. With these strengthening measures, the mechanical characteristics of the structure were increased and the amplitudes of stresses due to movement were reduced; thus the service life of the bridge was significantly extended. This was the first experience in France of strengthening this type of structure with bonded CFRP.

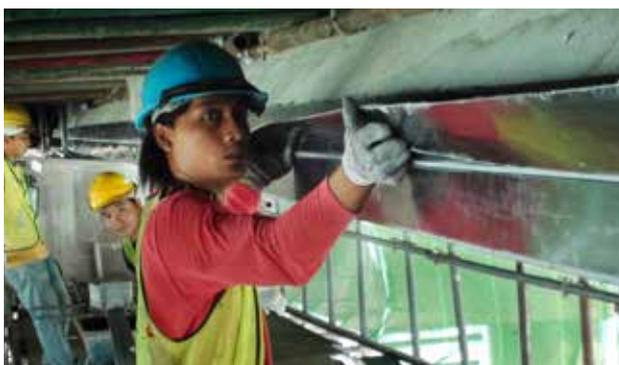
Installation CarboDur®

Engineers, using a layered build-up of the Sika CarboDur® CFRP System. Finally, all of the exposed concrete and CarboDur® plate surfaces were given a protective Sikagard® coating to protect them against UV light and future attack from the aggressive marine environment respectively.

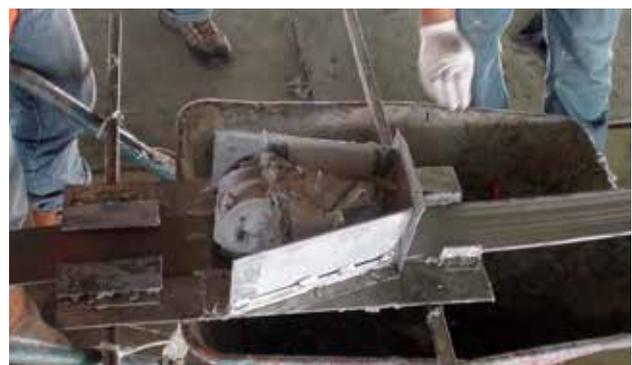
Coating of CarboDur® plates with Sikadur®

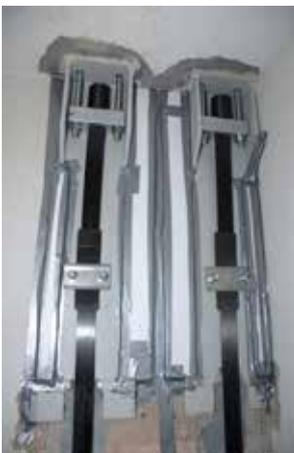
Anchorage of Sika CarboStress System

The Sika CarboStress® system was selected to achieve the necessary seismic resistance on the structure. This consisted of post-tensioned Sika CarboDur® CFRP plates anchored into the substrate. In the three stairwells of the building, a total of 12 Sika CarboStress® tendons were installed. Since these Sika CarboStress® tendons were relatively small, flexible and could be

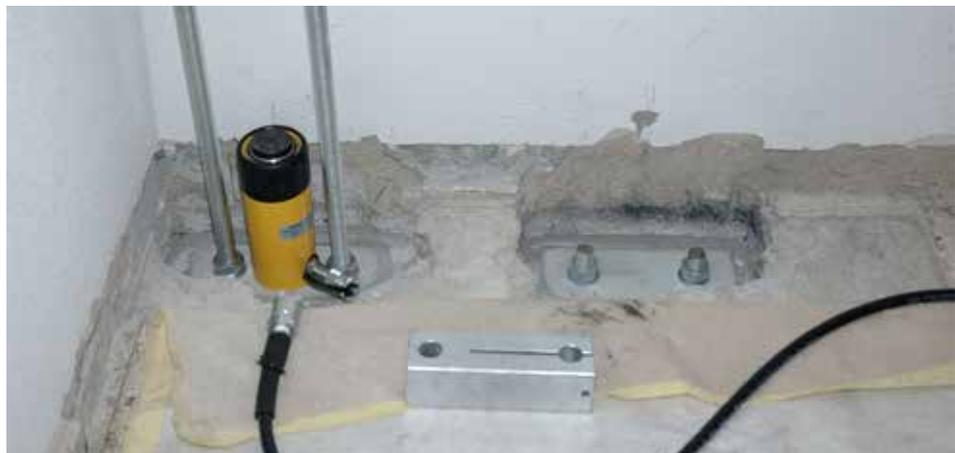
Pressure cylinder

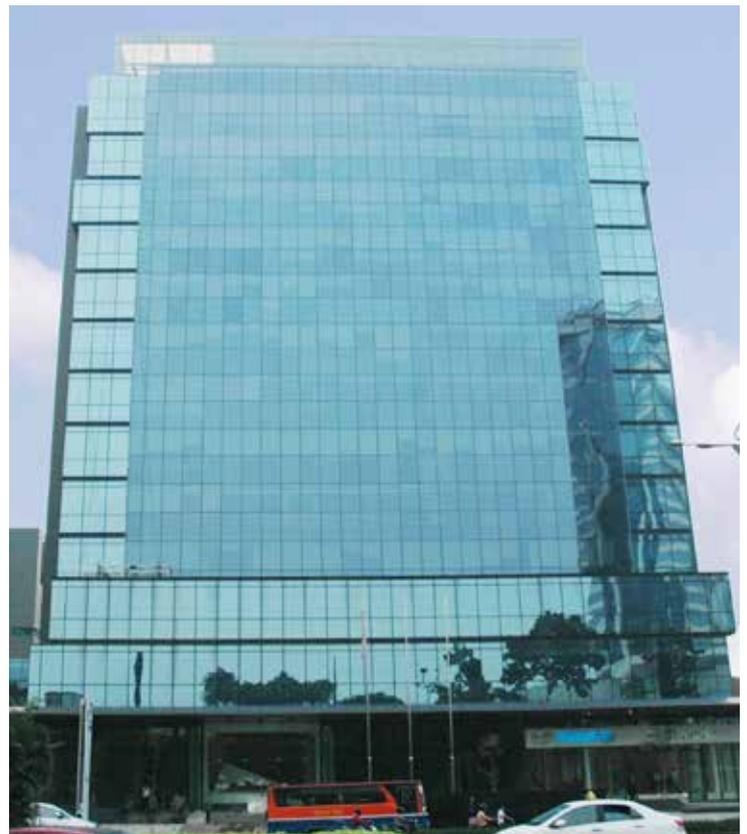
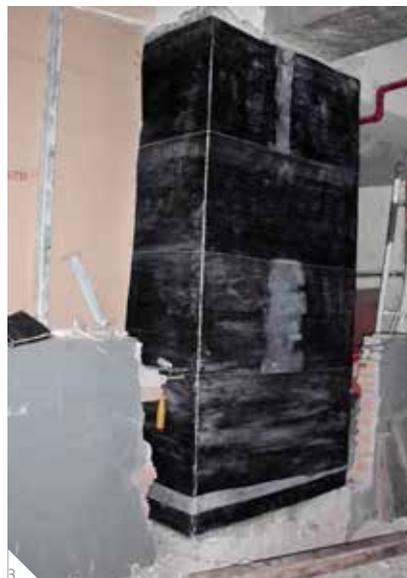
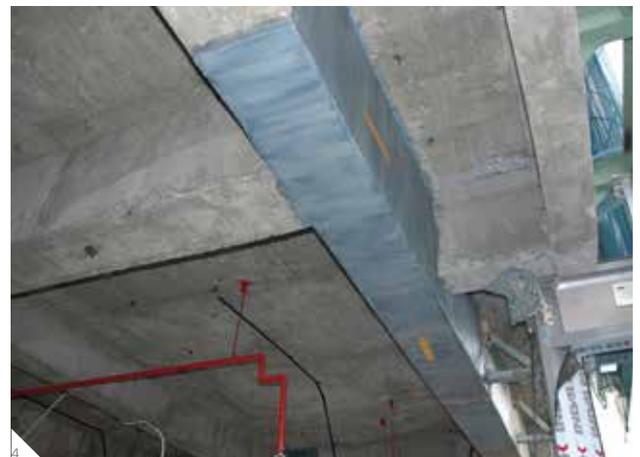
- 1 Beam strengthened without removing wall
- 2 CFRP installed around existing obstacles
- 3 Columns strengthened with SikaWrap® fabric
- 4 Reinforcement of beam with CFRP

The Engineers selected a Sika structural strengthening solution with carbon fiber-reinforced polymer (CFRP) materials, because of its effective performance despite its lightweight characteristics. Furthermore, the Sika systems allowed flexibility on site to overcome any issues and were easy to apply. The columns in the basement and ground floor were strengthened to provide increased confinement with the SikaWrap® fabric strengthening system. The cross beams were then either strengthened in flexure and against shear, or against shear only, by using a combination of Sika CarboDur® CFRP plates and SikaWrap® fabrics, with up to three layers of the fabrics being applied. During the installation works on site unforeseen conditions, including walls that could not be removed and voids in the existing concrete, were found. Another advantage of these Sika strengthening solutions was then that their design can be adjusted accordingly, so the works could still be completed successfully and with minimal break-out or removal of sound materials on site.

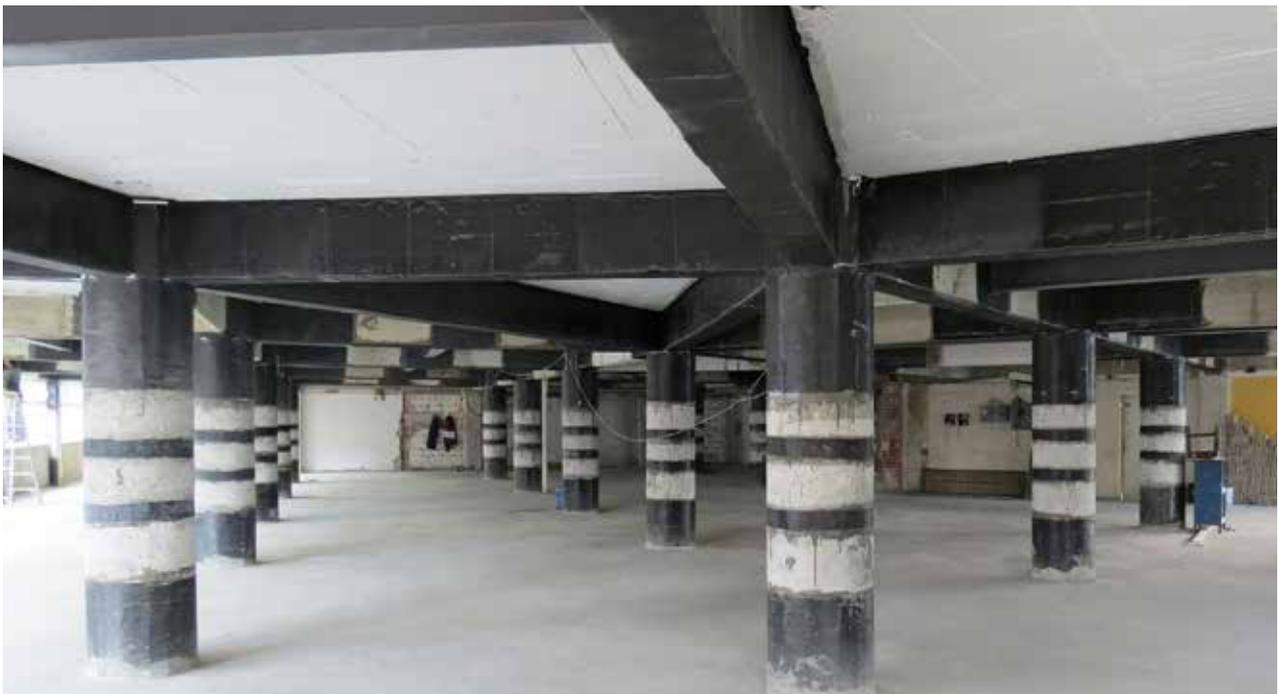
Beams and columns strengthened with SikaWrap®

A number of steps were then taken to refurbish and upgrade the whole building, including additional steel bracing and casting additional concrete, sealing existing cracks by injection and then overall structural strengthening. The beams were strengthened in flexure and shear using the SikaWrap® fabric strengthening system, the columns had continuous Sika CarboDur® CFRP plates installed along their axis over several storeys, then the columns were also wrapped with SikaWrap® fabric to increase their strength and ductility. The complete refurbishment project was easily completed on time due to the lightweight nature and rapid installation procedure for these Sika systems. The weight of the structure was only slightly increased, and no useable area was lost.

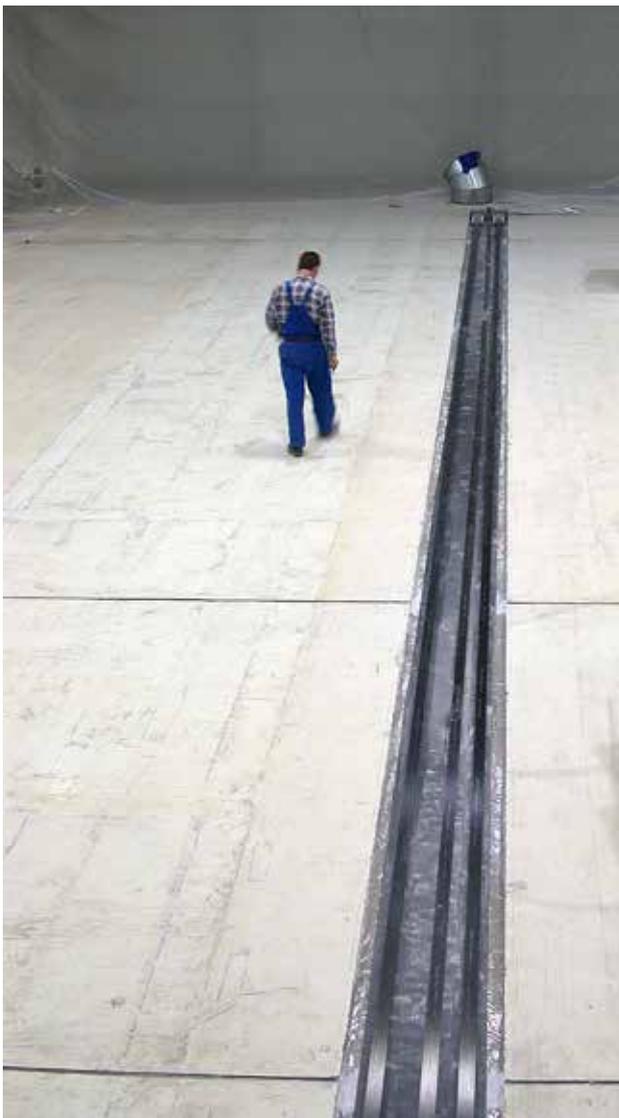
The longest post-tensioned CFRP-plates ever installed

With 29 m this is the one of the longest post-tensioned CFRP plates ever installed in the world.

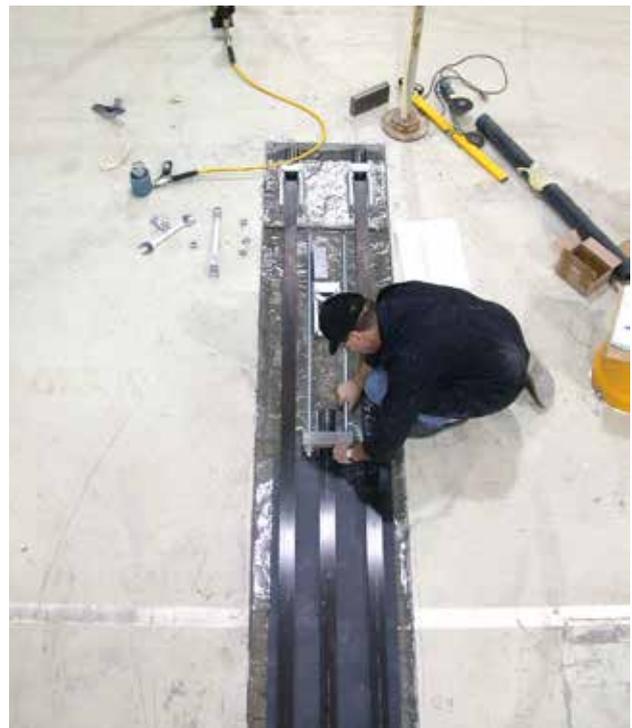
Plate and end-anchorage

System. Three tendons, consisting of CarboDur® plates and special end anchorage heads were installed to produce a united base without joints. The CFRP plates were then encapsulated into the concrete base to protect the system and to make the area ready for use.

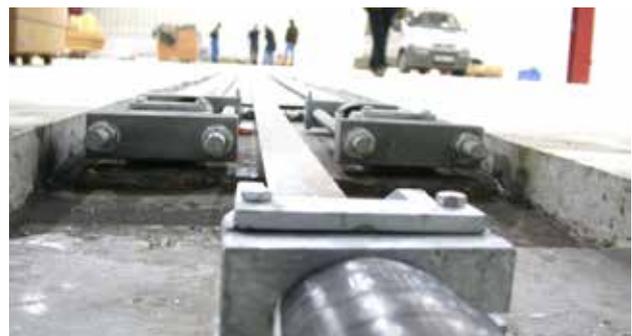
Base channel with post-tensioned CFRP plates

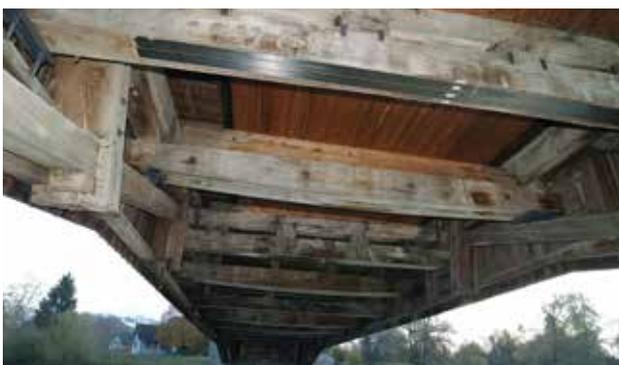
CarboDur® strengthened crossbeam

To refurbish the bridge the deck was removed and rebuilt, and Sika CarboDur® CFRP plates were bonded to the bottom of the crossbeams to reduce deflection. The installed plates were left exposed and uncoated to facilitate inspection and assessment, but to date the installation remains maintenance free.

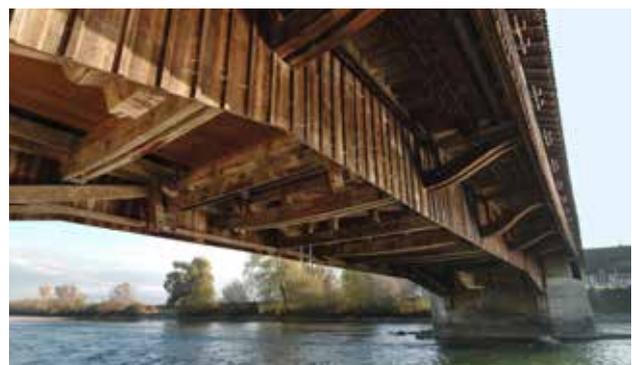
Bottom view of strengthening system

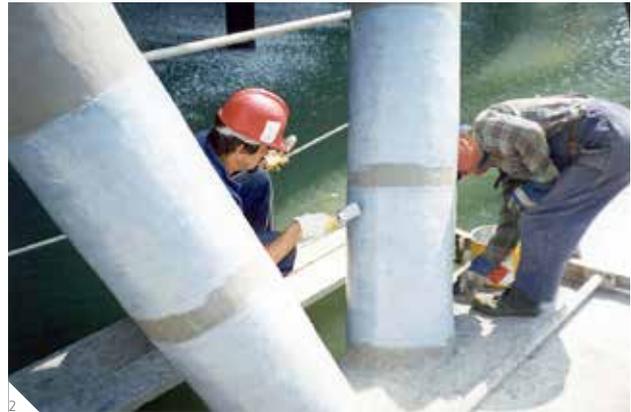
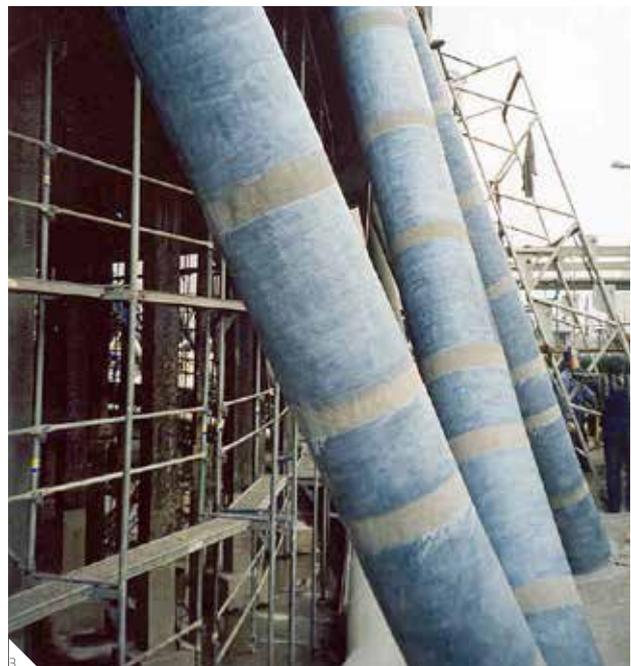
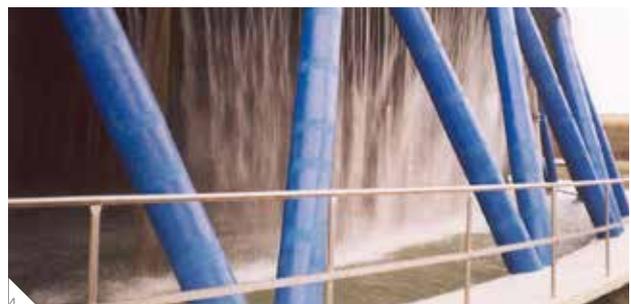
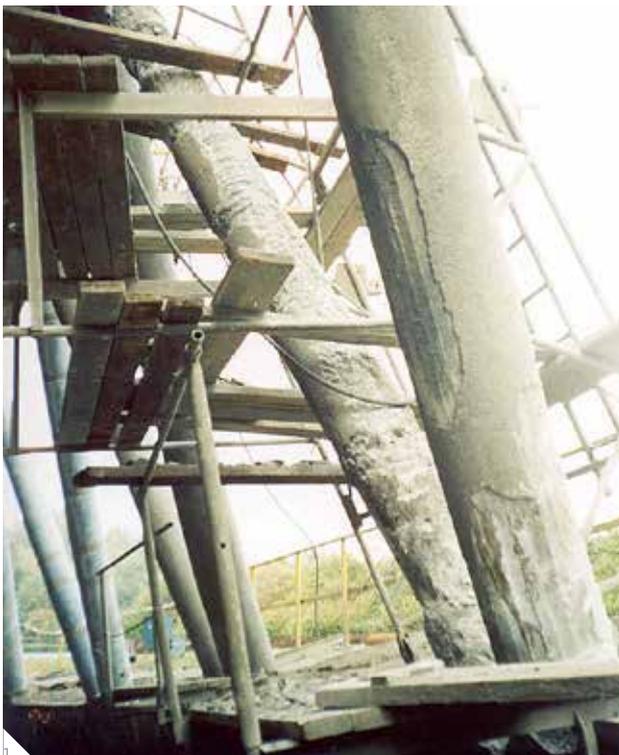
- 1 Damaged columns
- 2 Application of SikaWrap®
- 3 Installed strengthening system
- 4 Coated strengthening system

On 92 of the main supporting columns the concrete had spalled-off over corroding reinforcement in several areas, the steel was then exposed and continuing to corrode and lose significant cross section. The structure therefore now needed not only concrete repair and replacement on the damaged columns, but also a structural strengthening solution to reverse the loss of strength resulting from the corrosion and damage.

After removal of all damaged concrete and preparation of the surfaces, selected columns were repaired with sprayed concrete based on Sikacrete® admixture. The rest of all together 92 columns was then reprofiled with the Sika MonoTop® repair system and sealed with a Sikagard® impregnation. When the repairs were hardened the necessary confinement strengthening was carried out using SikaWrap® fabric in sections. Finally, all of the surfaces were overcoated with a Sikagard® protective coating for improved appearance and additional durability.

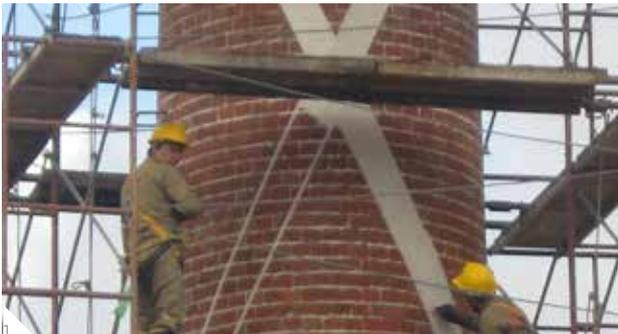
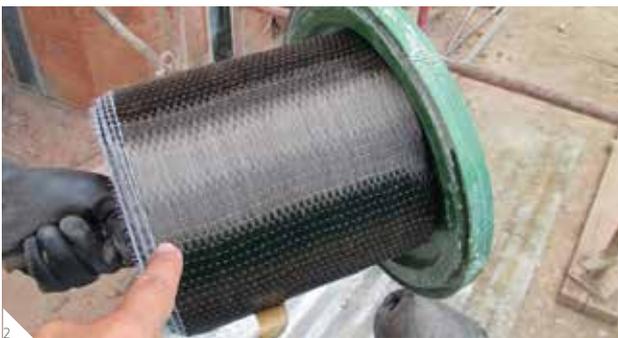
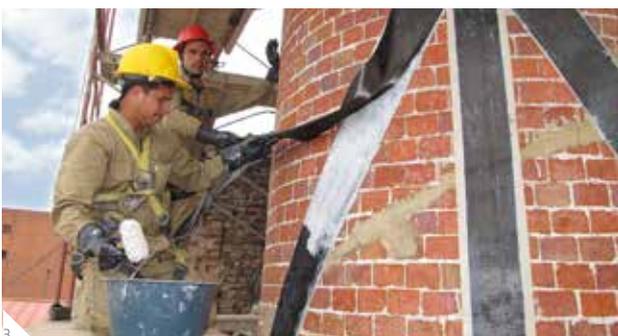
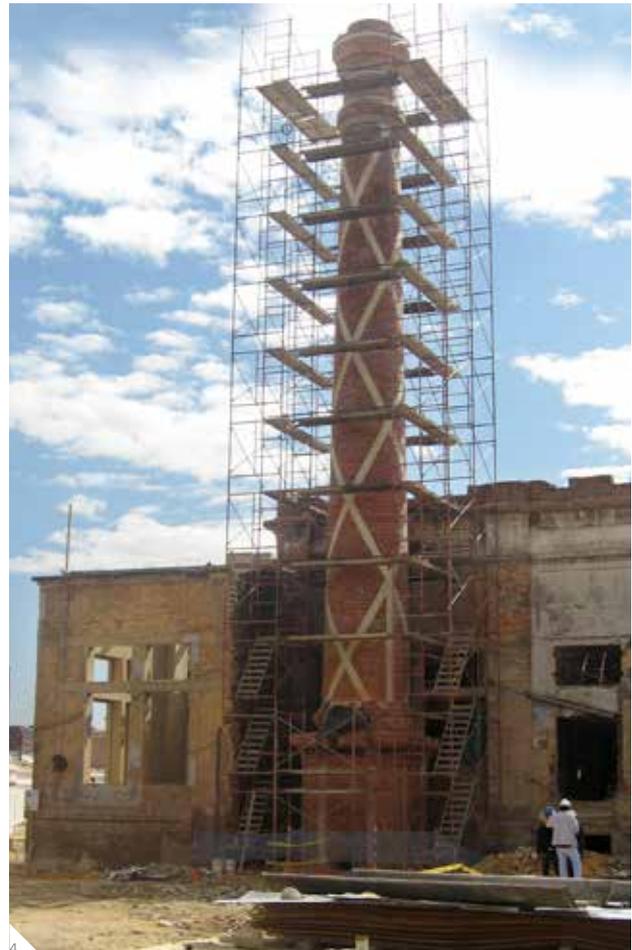
- 1 Substrate levelling
- 2 SikaWrap® roll
- 3 Installation of SikaWrap®
- 4 Coated strengthening system

A complete Sika solution was selected. After cleaning the structure thoroughly, Sikadur® epoxy mortar was applied to level the surfaces and prepare them for application of the SikaWrap® fabric strengthening system. SikaWrap® fabric strips were then cut to size and applied symmetrically, both diagonally and vertically, to improve the strength of the whole chimney structure with a uniform appearance. Finally the whole masonry chimney surfaces were overcoated with an acrylic protective coating.
